Mustang Repair & Refresh

Bob Azukas 1978 Mustang II Coupe

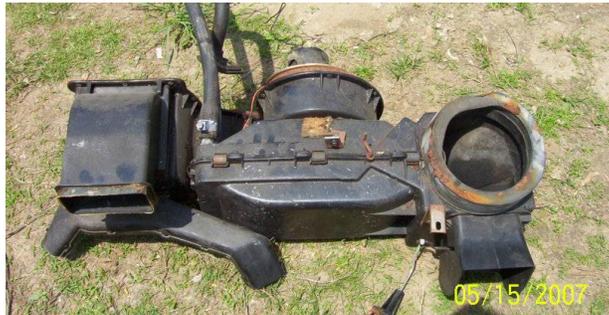
Back in June you read an article on the beginning of a heater core replacement in Bob's '78 Mustang II. This month I will finish the installation minus the aftermarket AC unit as it no longer works and Bob wishes to leave it out. With the heater box removed from the car, access to the core is easy.

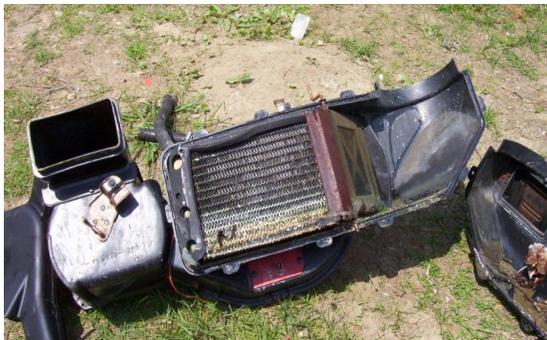
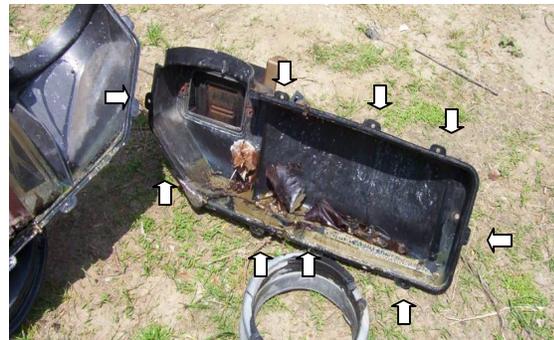
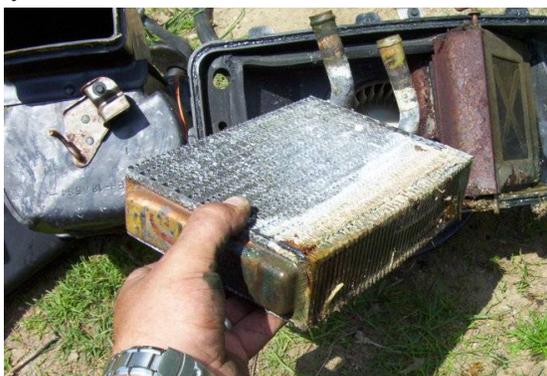
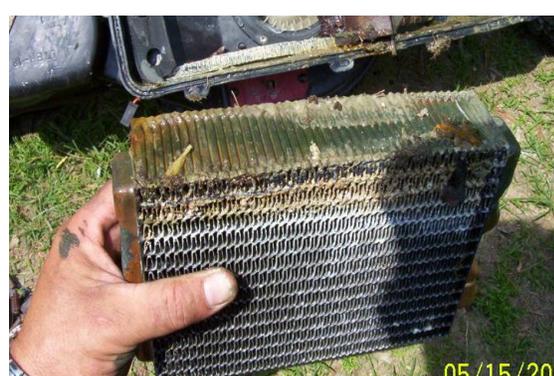
As you can see from the pictures this core has been leaking for a long time. The inside of the box is wet from the leaking coolant and out side debris that has collected in the heater over time. Before installing the new core assembly, the inside of the box was thoroughly cleaned as were all air ducts. Carefully place core in the box making sure all blend doors are in place and working freely, then install the other half of the box and secure with the clips that were removed earlier.

You need to remove nine clips from the heater box that hold the two halves together. Once the box is split the core can be removed.

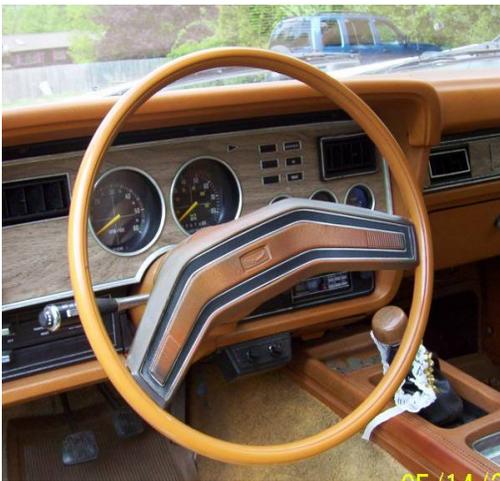
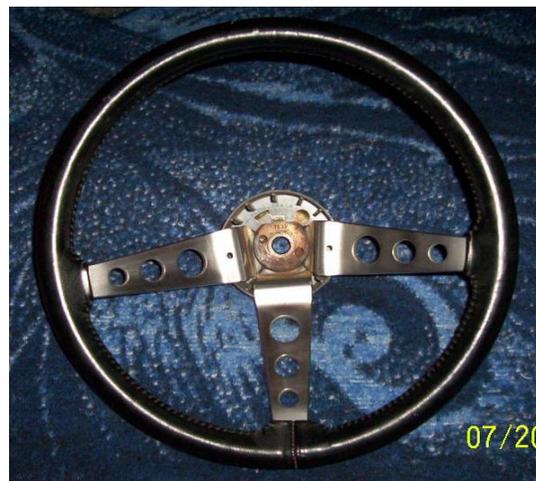
This wheel

for

this wheel

Next time I will cover the replacement of the original steering wheel to a factory sport wheel and check dash lights for operation.
