Mustang Repair and Refresh

Article by Lucien Boutin

Bob Azukas 1978 Mustang II Coupe

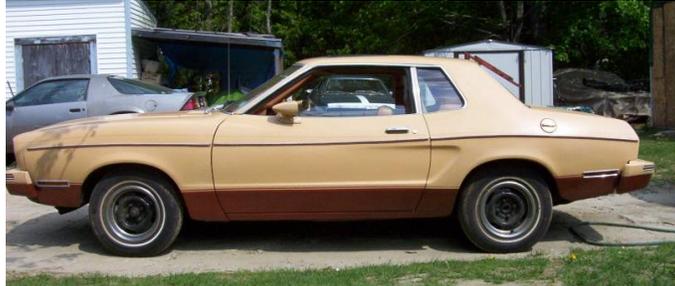
This 1978 Mustang II Coupe belongs to Bob Azukas. Bob asked me if I would do some repairs for him. The car is very clean and solid for its age. Some of the things that I will be doing will be changing the steering wheel, heater core, checking dash lights for proper operation, making sure car is running well and will be safe and reliable for the road.

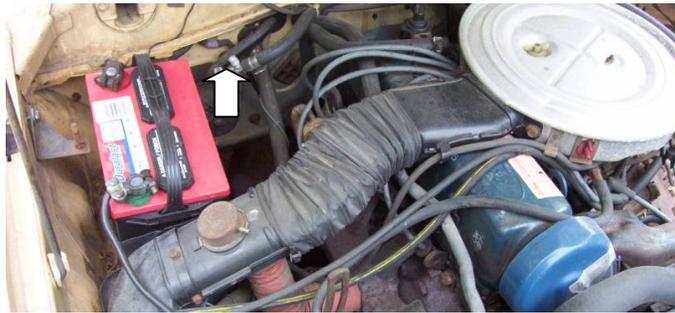
The first part of the project is to gain access to the heater core. The heater box is not really hard to get to on these cars. However this one had an aftermarket air conditioning unit installed many years ago and needs to be removed before the heater core can be accessed.

First the AC system needs to be checked to see if it is charged. There is a fitting under the hood on the AC line that looks like a tire valve. Carefully press the valve with a screwdriver to see if the system is under pressure. If the system is under pressure you need to have it evacuated at a local auto shop that does AC repair as venting the system into the air is illegal and dangerous. This one was dry as the freon had leaked out over the years.

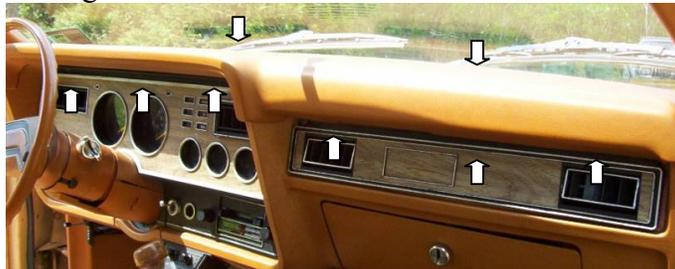
Next the cooling unit needs to be accessed from the inside by removing the upper dash pad. This is done by removing the series of screws that hold it to the main dash panel.

Also the dash bezel over the glove box needs to be removed.

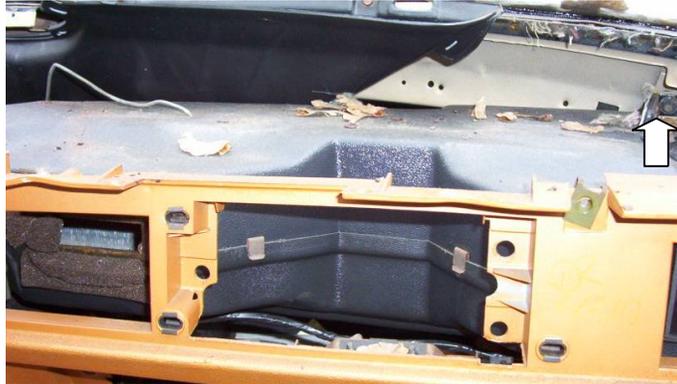
Once the dash pad and bezel are removed the cooling unit is exposed. The unit was designed to fit just under the dash pad making it a separate unit from the heater box.

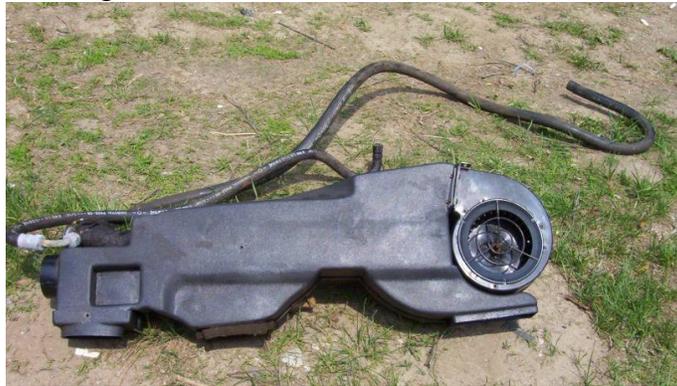
The unit is a tight fit and is held in by one bracket as the rest of it just sits on top of the inner dash components. To get the unit out, the main dash had to be unbolted from both ends and moved out. The lines going to the compressor also have to be removed so they can be brought through the firewall when the evaporator is removed. Once this was done the AC unit had just enough room to be removed.

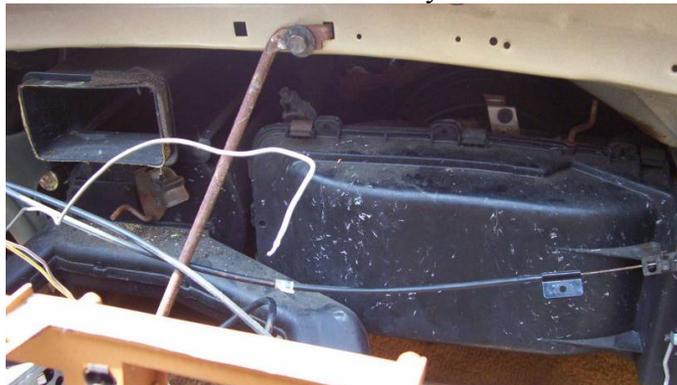
The under dash unit consist of the evaporator, case and its own fan to circulate the cool air. Once removed access to the heater box was easy.

To remove the heater, four bolts on the engine compartment side have to be removed. The heater hoses also need to be disconnected under the hood. Inside, the control cables need to be disconnected from the blend doors. Once disconnected pulling heater box and hoses from car is easy. Next month I will cover servicing the heater core assembly.
